OFGEM

**REPORT ON
SUPPORT INVESTIGATIONS
INTO RECENT BLACKOUTS IN
LONDON AND WEST MIDLANDS**

**VOLUME 2
SUPPLEMENTARY REPORT**

**PROTECTION COMMISSIONING &
PERFORMANCE**

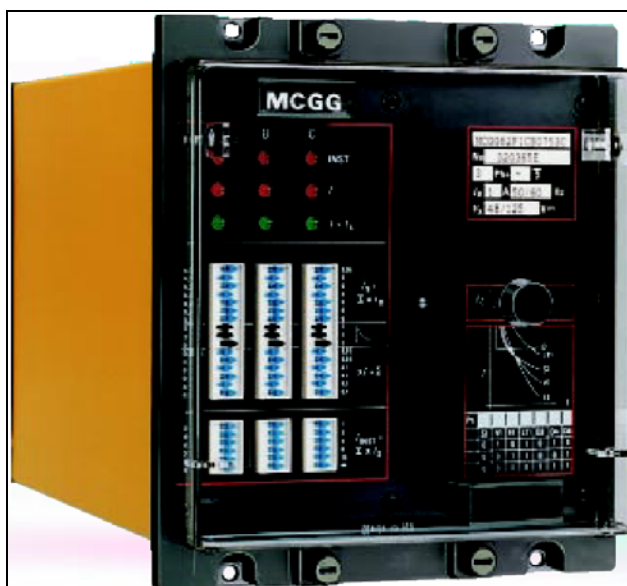
Figure 3 – Type of Electronic Back-Up Overcurrent Relay that Tripped at Wimbledon

The South London Blackout was caused by the incorrect operation of the "System Back-Up Overcurrent" protection for the New Cross 275 kV circuit number 2 from Wimbledon, after the load current on the circuit increased, following emergency network switching operations, to disconnect plant with an apparent problem at Hurst substation. The increased load current was well within the expected capability of the circuit and it should not have tripped.

The relay rating error should have been detected during standard commissioning tests and procedures laid down by NGC, but it was not. The result was that the protection system was commissioned with a latent defect that remained hidden for over 2 years, until the system emergency that arose on 28 August 2003. The latent protection system defect prevented the Wimbledon to New Cross 2 circuit from being used to its full capability during a transmission system emergency.

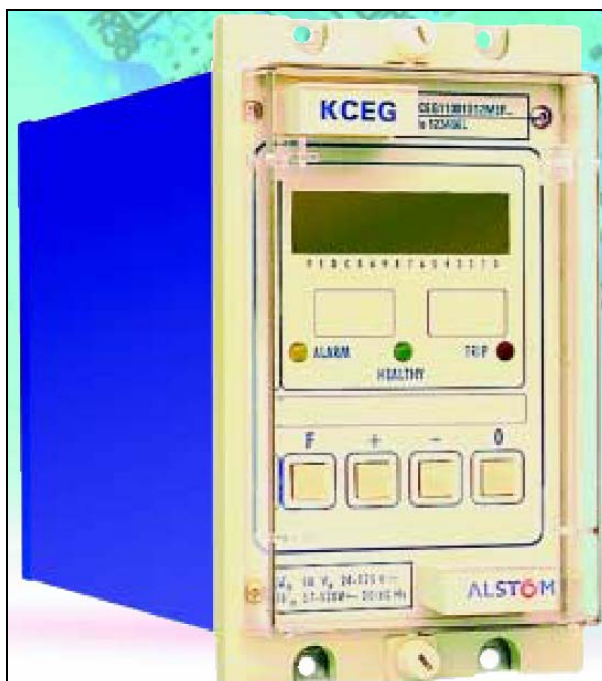
Figure 5 – Type of Numerical Back-Up Overcurrent Relay that Tripped at Hams Hall

The East Birmingham Blackout was caused by the incorrect operation of the "Interlocked Overcurrent" protection [scheme] for the 132 kV side of the new 400 kV/132 kV step-down transformer SGT8 at Hams Hall. The incorrect protection system operation occurred when the load current on SGT8 increased, following an emergency network switching operation to unload the parallel transformer SGT6. This was to urgently deal with a serious secondary system problem that had been discovered for SGT6, some hours after it had been re-commissioned, following some weeks of substation modification work. The increased load current was well within the expected capability of SGT8 and it should not have tripped.

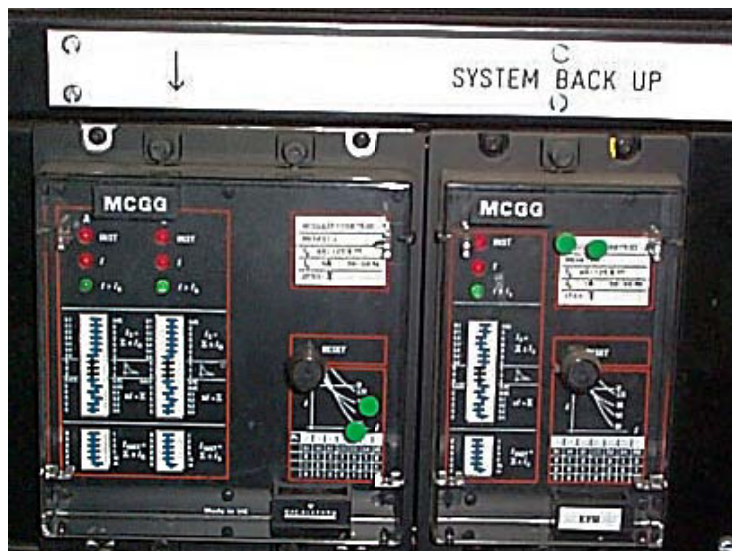
Figure 12 – View of New X 2 Back-Up Overcurrent & Earth Fault Relays at Wimbledon

photographed by the Consultants on site on 16 October 2003, for the New Cross 2 Feeder, is shown in Figure 12. It can be seen that the relays have clearly visible data tables in the top right quadrants of their front plates, and the relay rated current is one of a number of parameters that is clearly displayed.

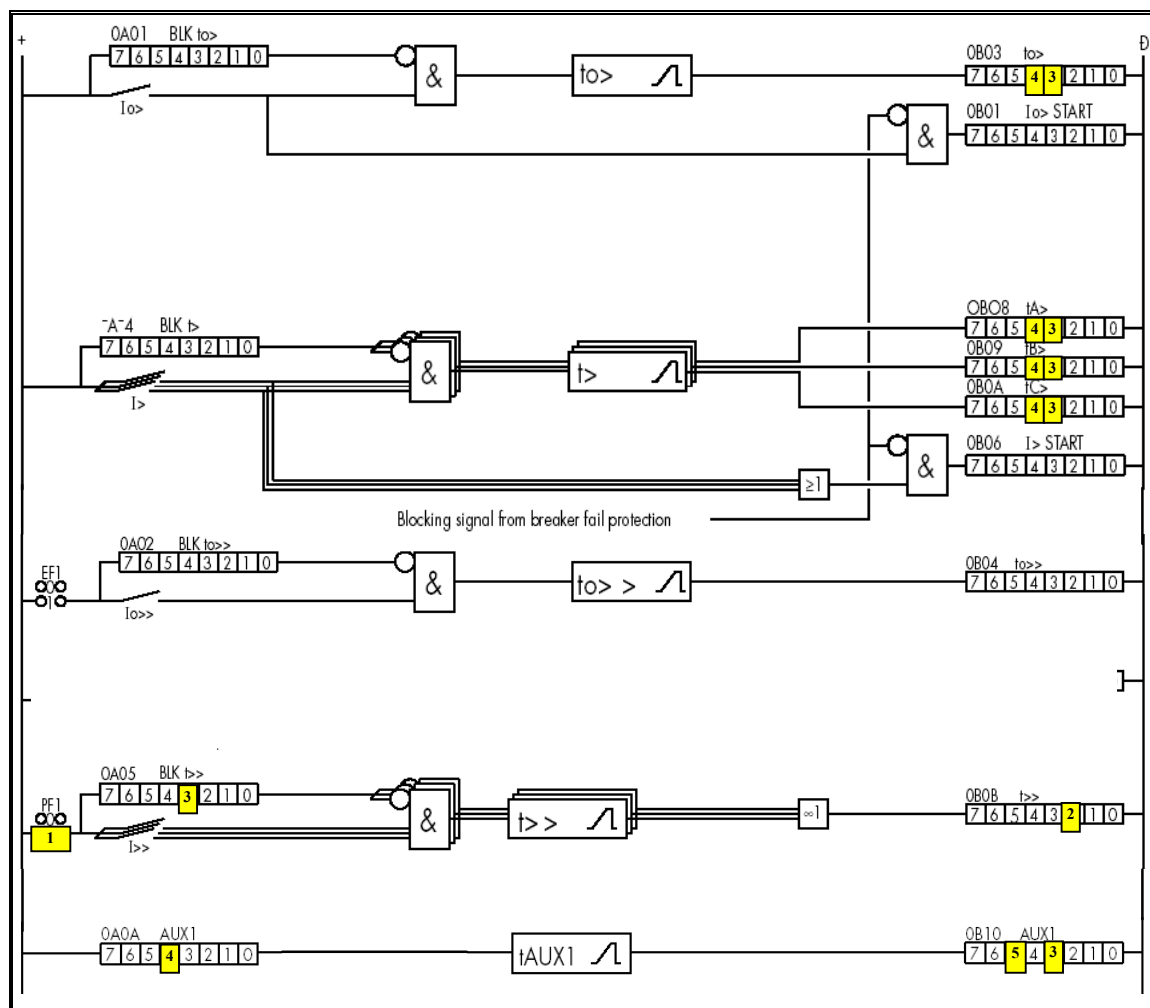
Figure 28 – Summary of Contractor’s 132kV Protection Scheme Logic Configuration

Figure 28 is a distillation from the KCGG142 service manual, by the Consultants, of relevant protection element functionality for the 132 kV protection scheme that had been engineered by the Contractors. The Input and Output "Mask" settings that had been applied to the relay, in accordance with the Contractor's drawing number T1/42/152119, have been shaded in Figure 28. The additional overcurrent protection elements I>> + t>> were enabled via the PF1 Function Link setting and they were used to provide the ILOC protection function. With reference to Figure 29, which shows the scheme wiring external to the KCGG142 relay, a normally closed Busbar Protection Trip Relay (BBTR) contact energises opto isolator input 3 when the BBTR is not operated. Figure 28 shows that the blocking input mask for the I>> protection function is set to respond to opto input 3 being energised and hence to non-operation of the BBTR. This provides the interlocking for the ILOC protection. For some reason, instead of using the t>> adjustable timer to provide the required ILOC delay of 200 milliseconds, the t>> was intended to be set to zero and the I>> + t>> protection function was arranged to operate output relay 2 without delay.

It can be seen from Figure 28 that there is no setting facility within the KCGG142 relay to disable its $I > + t >$ and $I o > + t o >$ Overcurrent and Earth Fault base elements - other than to permanently energise an opto isolator to block the elements. It can also be seen that the Contractor had intended that these protection elements should operate output relays 3 and 4. With reference to Figure 30, it can be seen that the non-interlocked base protection

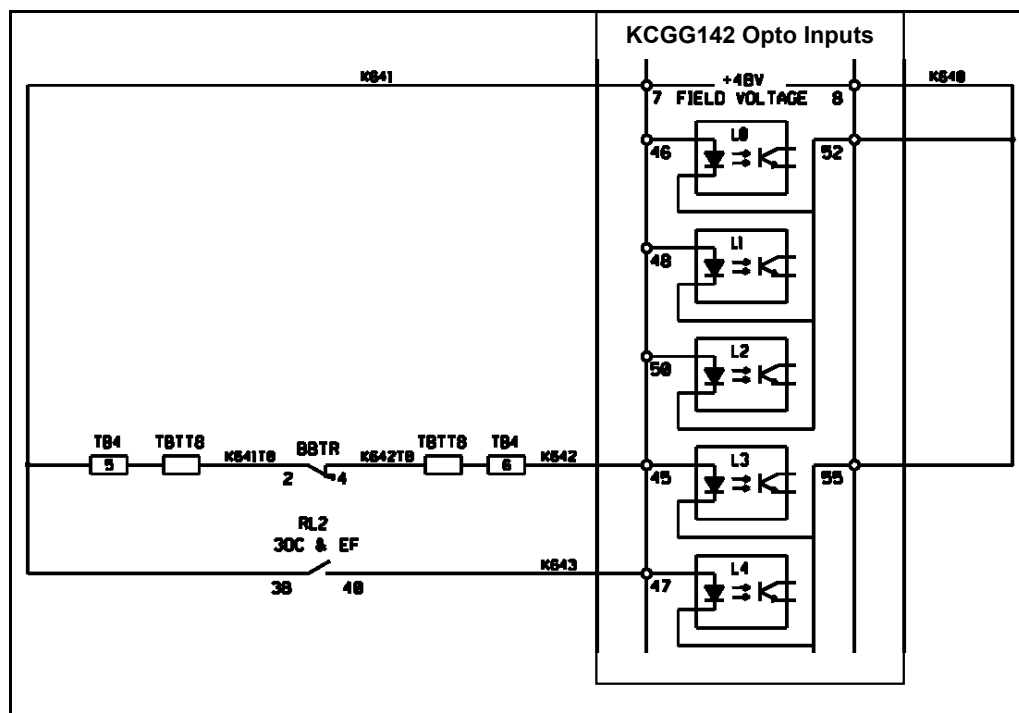
Figure 29 – Summary of Contractor’s Protection External Scheme Wiring

With reference to Figure 29, the contact of output relay 2 was wired to initiate opto-isolator input 4 and, with reference to Figure 28, this opto-isolator was set to initiate the scheme timer tAUX1, as determined by its input mask setting. Timer tAUX1 was to be set to 200 milliseconds to provide the required ILOC protection time delay and tAUX1 was configured to operate output relays 3 and 5, via the tAUX1 output mask settings. It can be seen from the scanned extract of Trip and Alarm outputs from the Contractor’s diagram in Figure 30, that output relay 3 is used to initiate the Back-Up protection Trip Relay (BUTR). Contacts of this relay were wired to initiate SGT8 132 KV Circuit Breaker tripping and intertripping of its 400kV Circuit Breaker. The relay 5 contact was used to initiate an alarm, but it can be seen from Figure 30 that the Contractor had named the alarm function “SBU EARTH FAULT PROT.” Rather than “ILOC protection”.

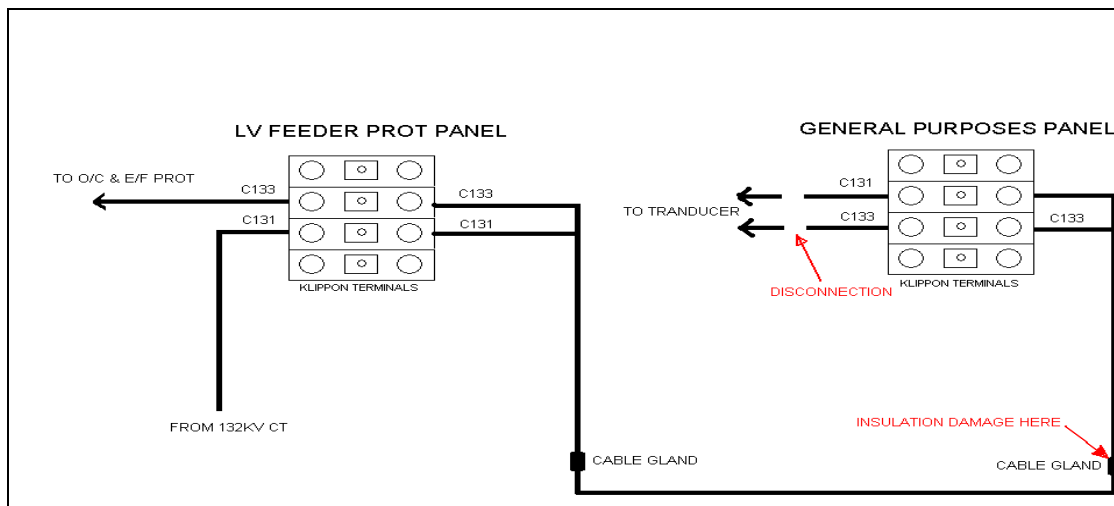
Figure 37 – Initial Situation as Found

With reference to Figure 37, cable damage (burning insulation) was discovered in the General Purposes relay panel at a gland. When this cable was identified, it became apparent that wires C131 & C133 were open circuit.

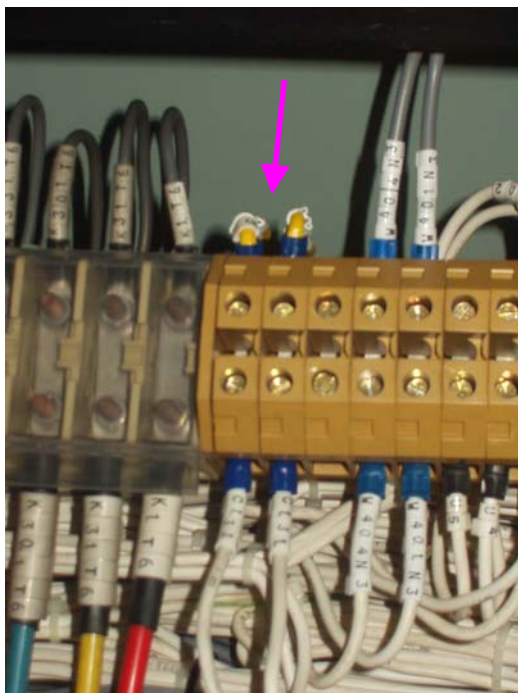
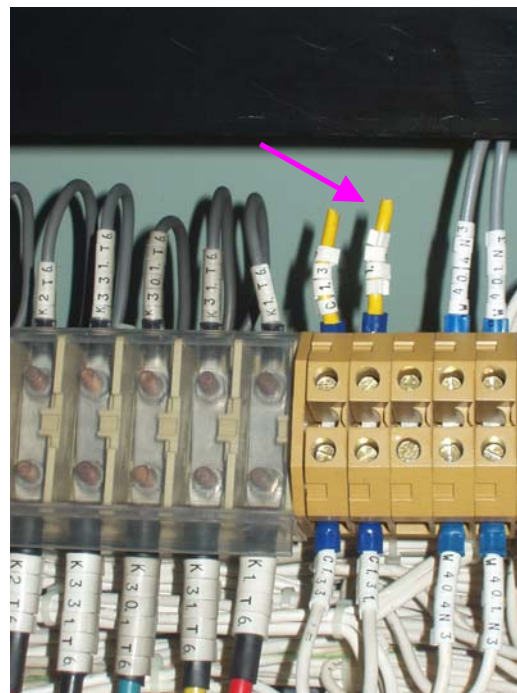
Figure 38 – Views of the Cut 132kV CT Circuit Wiring in the SGT6 400kV Relay room

a) Wiring as found with problem not visible

b) Wiring after problem exposed
