OFGEM

**REPORT ON
SUPPORT INVESTIGATIONS
INTO RECENT BLACKOUTS IN
LONDON AND WEST MIDLANDS**

**VOLUME 2
SUPPLEMENTARY REPORT**

**PROTECTION COMMISSIONING &
PERFORMANCE**

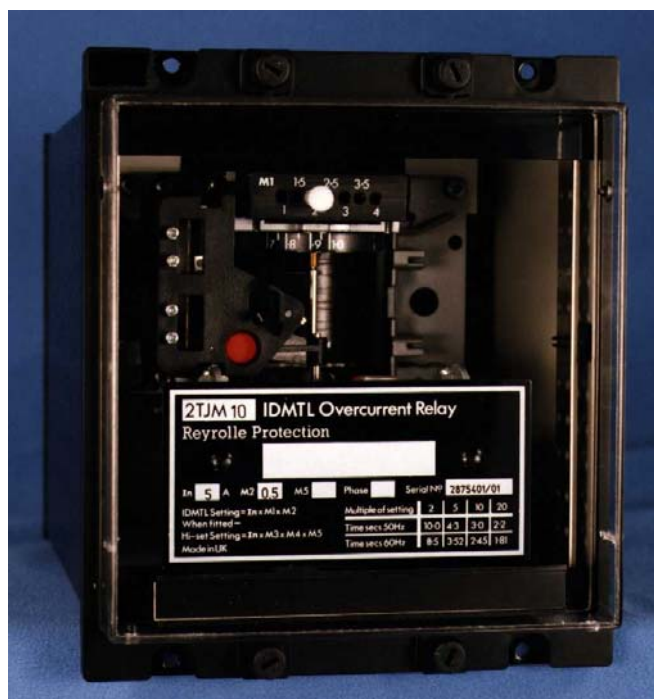
Figure 2 – Example of a Single-Phase Electromechanical Back-Up Overcurrent Relay

In consideration of relative complexity, the single phase electromechanical overcurrent relay depicted in Figure 2 might look complicated, but it only has two user settings: (i) a current threshold setting; (ii) a time curve multiplier setting. It has a single operating time characteristic curve where the tripping time is dependent on the level of the applied current. Typically, three of these units would have been applied to provide back-up overcurrent and earth fault protection for a transmission circuit. For the type of relay depicted in Figure 2, the settings are clearly visible from the front of the relay and the existence of the relay functions within the protection scheme would have been clear by the presence of the relays on the relay panel, by the visibility of their contents and by referring to the protection AC and DC scheme wiring diagrams.

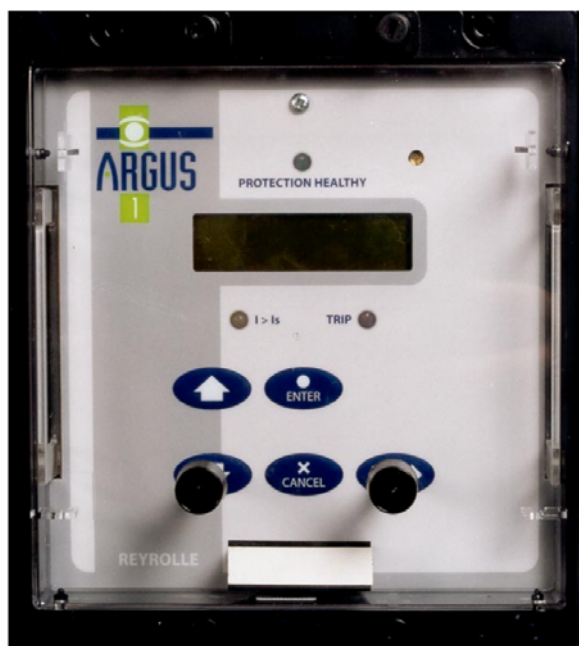
Figure 4 – Type of Numerical Back-Up Relay Originally Proposed for Wimbledon

The relay type shown in Figure 4 had originally been proposed for use at Wimbledon, at the Design Intent Document (DID) stage, but relay types similar to that shown in Figure 3 were ultimately applied at Wimbledon for System Back-Up Overcurrent protection. The relay type shown in Figure 5 was the type that issued the unwanted trip of SGT8 at Hams Hall and Figure 6 explains its user interface functions.

Whilst the relay types depicted in Figure 4 and Figure 5 might appear to be simple, with each having just four or five user interface push buttons, three LED status indicators and a liquid crystal display, their appearance is misleading. Each of these relay types actually provides a wide range of protection elements, non-protection functions and scheme logic functions, with many settings and options to select. Theoretically, it is not even essential for a modern protection unit to have an integral user interface if it can be set externally, through a serial communications port, using a manufacturer's software settings tool running on a laptop PC.

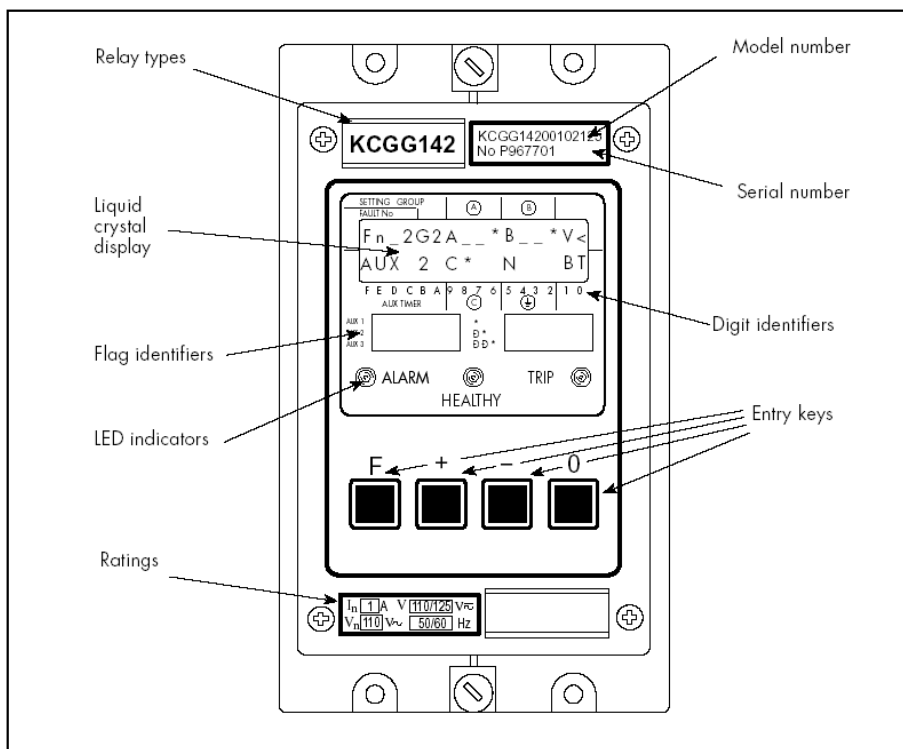
Figure 6 – Explanation of User Interface Functions for KCGG142 Numerical Relay

Whatever was the source of the confusion here, the scheme engineered by the Contractor for SGT8 ILOC protection and which was based on the KCGG142 multi-functional numerical (refer to Figure 5 and Figure 6), was not directly in accordance with NGC's specified requirements and this added further to the confusion.

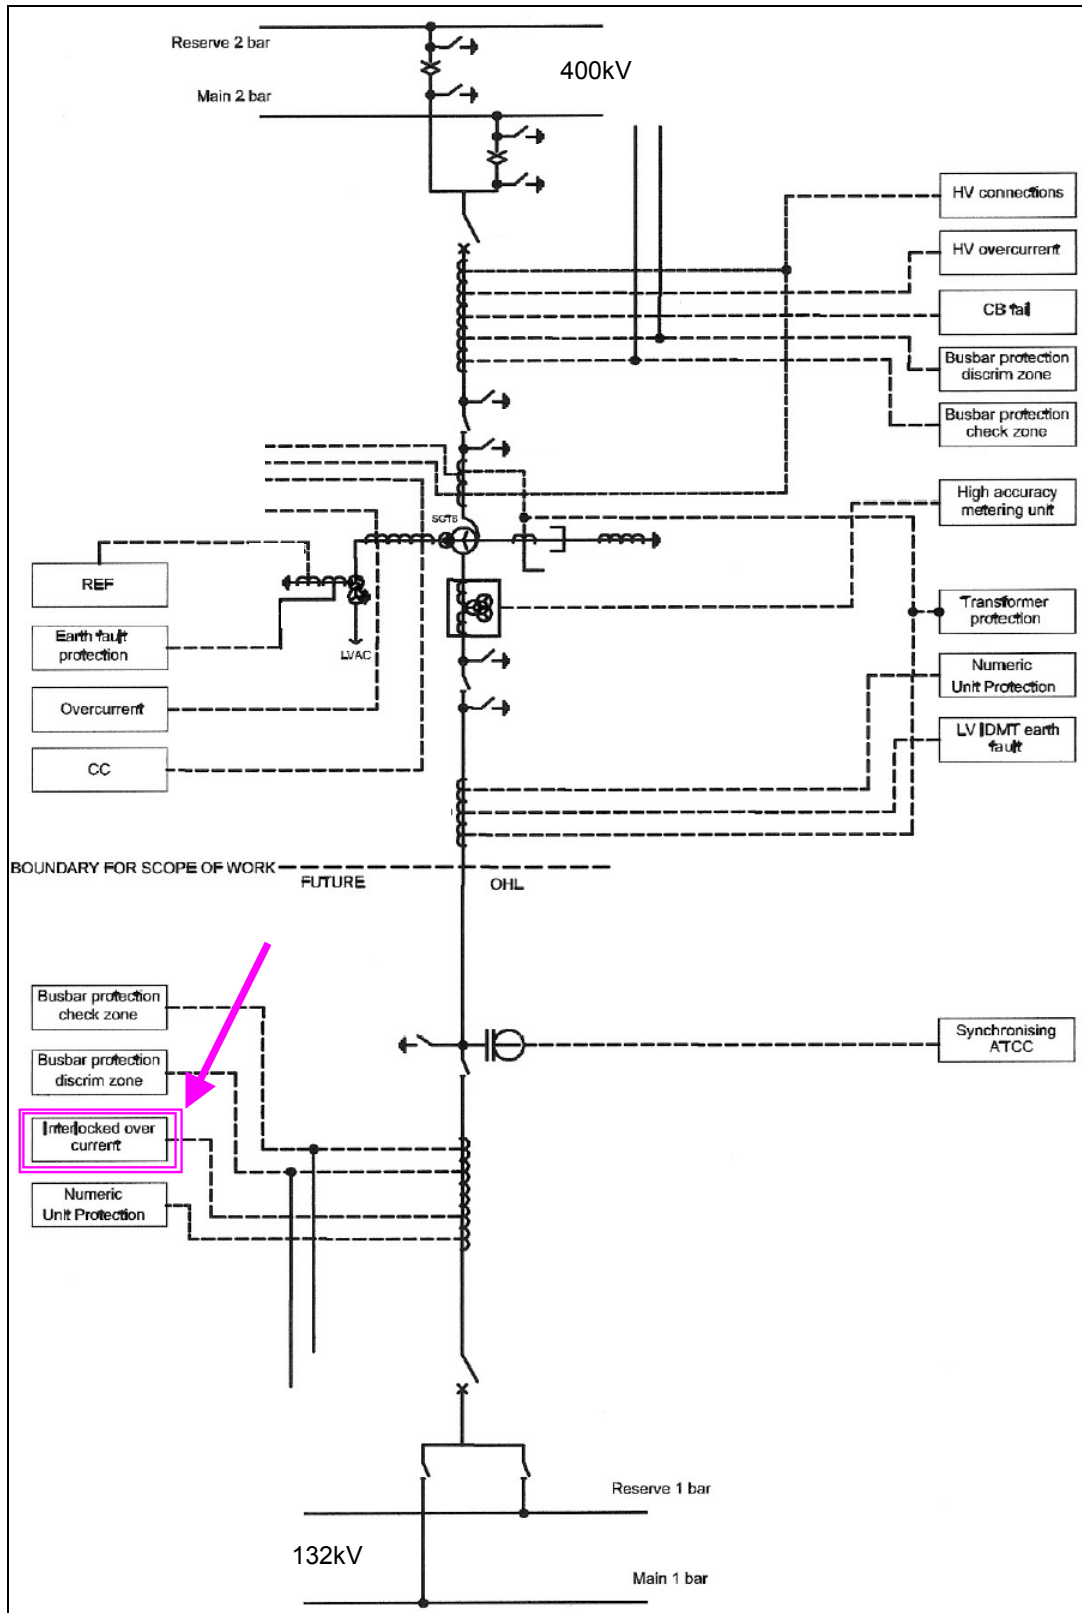
Figure 24 – Extract from NGC Tender C/XT019 Drawing 29/25395 for SGT8

In accordance with NGC Tender Documents C/XT019, the 400 kV protection systems for existing plant (including the 400 kV/132 kV transformer SGT6) were to be retained. New protection systems were only required for new plant, which included the 400 kV/132 kV transformer SGT8. In accordance with NGC requirements and since the 132 kV switchgear was remote from the 400 kV substation, through approximately 1km of intervening 132 kV overhead line, the required 132 kV protection scheme for SGT8 included “Unit Protection”, based on differential current relays, with optical fibre communication between them. One of the 132 kV differential relays had to be located in a relay cubicle at the 400 kV substation, together with the 132 kV back-up earth fault protection that was also required. The other differential relay had to be located at the 132 kV substation, along with the specified “Non-Unit” Interlocked Overcurrent protection (ILOC). The required arrangements were summarised in the protection schematic diagram with Tender Document C/XT019 and an extract from this is given in Figure 24, with the required 132 kV ILOC protection function highlighted.

Whilst the diagram quoted in the tender extract in Figure 25 was not available for review, the text summary of the protection required at the 132 kV substation concurs with the scanned diagram from the 400 kV tender document given in Figure 24. It should have been clear to the Contractor and to NGC staff that all that was being requested at the 132 kV substation for SGT8 was the receiving end current differential relay for the unit protection and the Interlocked Overcurrent (ILOC) protection, plus some sundry equipment, but nothing more. It should have been clear from the drawing with the 400 kV tender documents (see Figure 24) that any System Back-Up protection was to be in the form of HV Overcurrent protection and LV Earth Fault protection only, with both sets of protection being located at the 400 kV substation and not at the 132 kV substation.

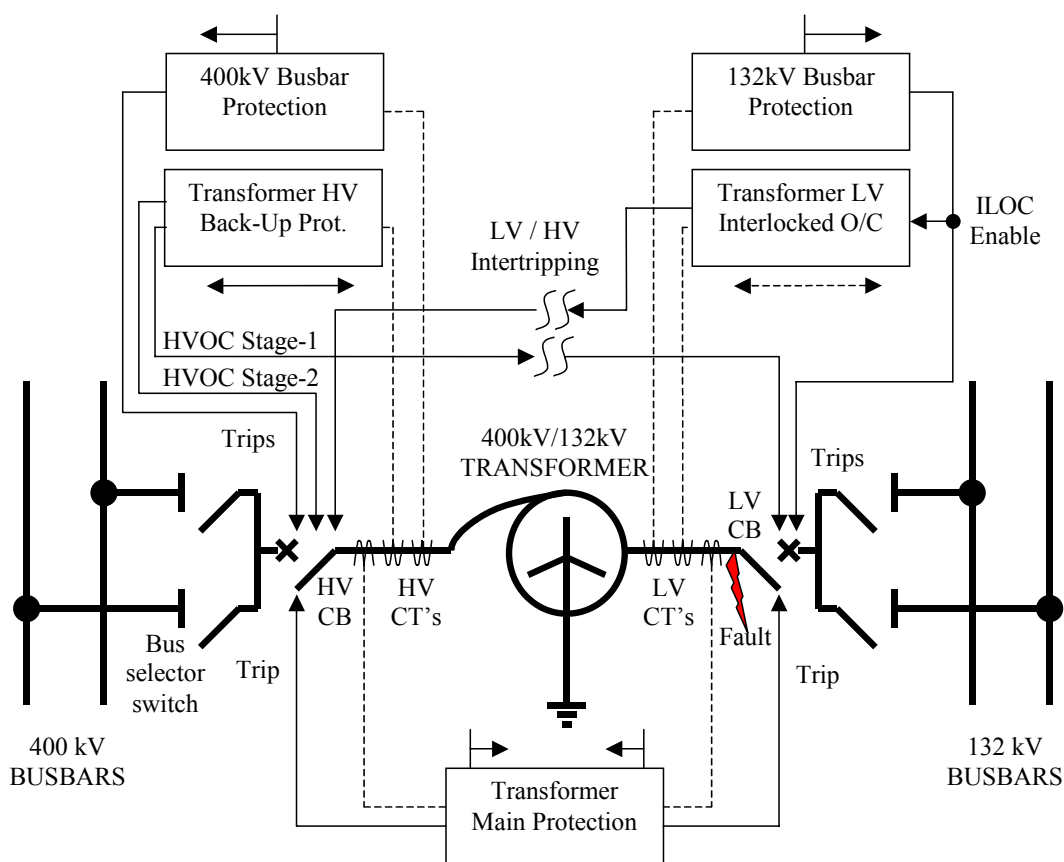
Figure 26 – Illustration of the Purpose and Application of 132 kV ILOC Protection

Figure 26 is an explanatory sketch for a 400 kV/132 kV transformer application where all the 132 kV CT's are on the transformer side of the 132 kV CB. It is a simplified sketch that does not show all the protection functions that would be provided, but which shows at least one main protection system for the busbars, "unit protection" power transformer and the "non-unit" transformer HV back-up protection. In addition, for simplicity, an intervening line between the transformer and the 132 kV substation (as at Hams Hall) has not been considered. The zone/direction of coverage provided by each set of protection has been indicated by arrows, together with trip paths and the utilisation of CT's.

As illustrated in Figure 26, it is possible that a fault (short circuit) could occur within the short zone between the 132 kV CT's and the CB. This fault would be seen within the zone of coverage of the 132 kV busbar protection, but the busbar protection is normally only arranged to trip the necessary 132 kV CB's to clear a busbar fault. There are a number of operational reasons why it would be undesirable for the 132 kV busbar protection to trip any 400 kV transformer CB's. For example, an additional tertiary winding of the power transformer, which is not shown in Figure 26, could be providing a source of AC power for the substation or it could be connected to reactive compensation equipment for the transmission system, such that 400 kV disconnection of a transformer would be undesirable when not absolutely necessary.

For the fault shown in Figure 26, the busbar protection tripping of the 132 kV transformer CB would not clear the fault current infeed from 400 kV through the transformer. The 400 kV fault current would cause the HV back-up overcurrent to pick-up, but this protection will only operate after a time delay that is set to ensure that there will be no risk of back-up protection operation during the time it would normally take to clear a 132 kV busbar short circuit. For a fault at the location shown, it is desirable to clear the 400 kV fault current infeed more rapidly than the "Stage-2" operating time of the HV back-up overcurrent protection, since a long delay in tripping would result in more extensive plant damage (especially for Gas Insulated Switchgear) and in a bigger disturbance to NGC and DNO customers, as a result of a prolonged voltage dip. It is the purpose of 132 kV interlocked overcurrent protection to provide more rapid clearance of the 400 kV infeed to a fault between the 132 kV CT's and the CB by inter-tripping the 400 kV CB

Since the 132 kV busbar protection will respond only to a busbar fault or to the type of short zone fault indicated in Figure 26, the operation of the ILOC protection is arranged to be interlocked with operation of the 132 kV busbar protection. A busbar protection trip contact should be used to arm the ILOC protection. In the event of normal clearance of a busbar fault, the ILOC protection would pick-up during fault clearance, but the fault would be cleared before the ILOC 200 millisecond time delay expires, such that the ILOC protection would not trip. In the case of a short-zone fault between the 132 kV CT's and the CB, the ILOC protection would remain picked up after 132 kV CB tripping and it would subsequently inter-trip the 400 kV CB.

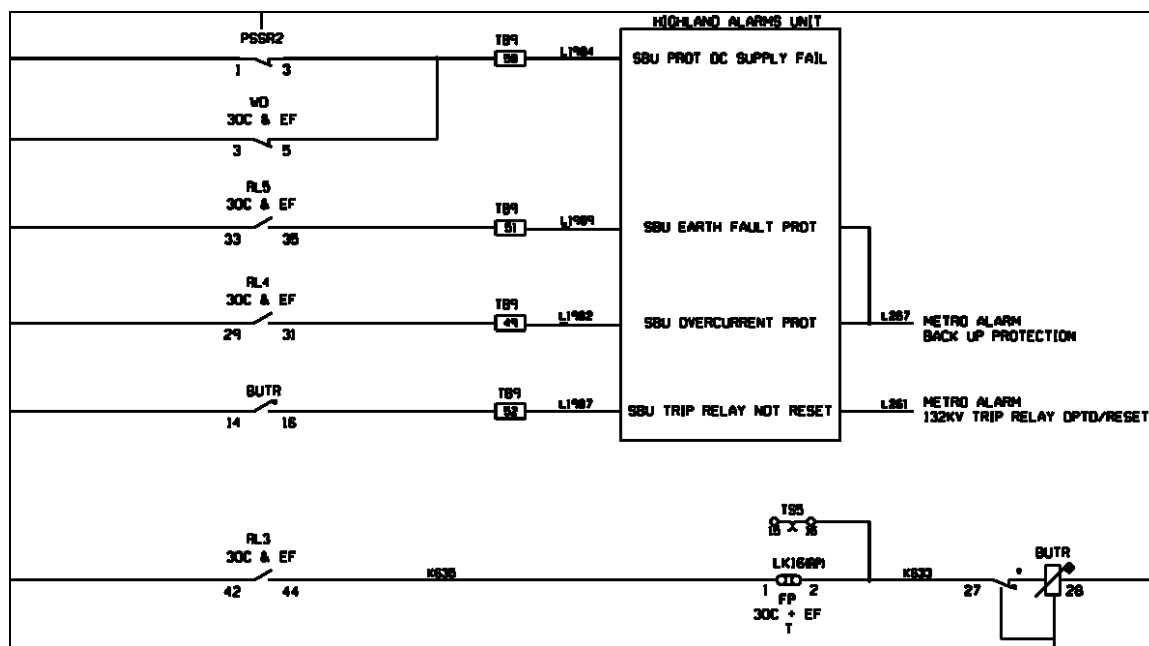
Figure 30 – Summary of Contractor’s Protection Scheme Alarm + Trip Outputs

It can be seen from Figure 28 that there is no setting facility within the KCGG142 relay to disable its $I > + t >$ and $I o > + t o >$ Overcurrent and Earth Fault base elements - other than to permanently energise an opto isolator to block the elements. It can also be seen that the Contractor had intended that these protection elements should operate output relays 3 and 4. With reference to Figure 30, it can be seen that the non-interlocked base protection
